Manhole Inspection Summary

Manhole # S39II_009MH

Location Address: **FEDERAL ST**

Cross Street: **ENSOR ST**

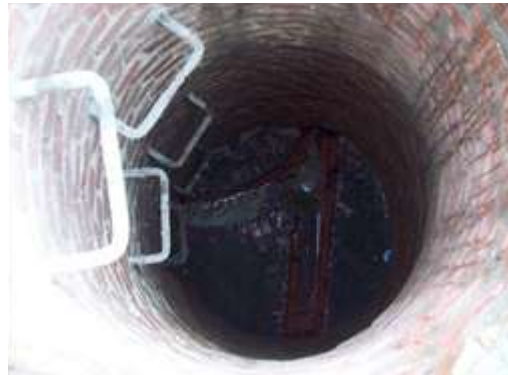
Top View

Infiltration: ☐ None ☐ Joint ☐ Cracks ☐ Mortar ☐ Roots ☒ **Wall**

INFILTRATION AT CORBEL WALL

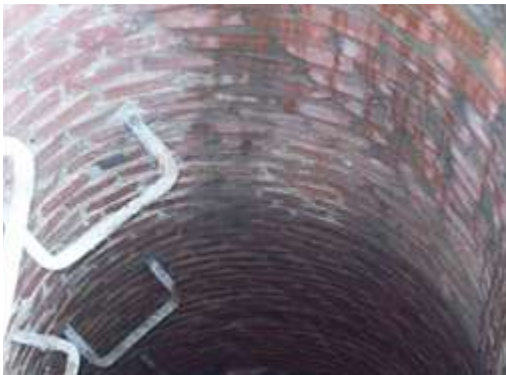
Defect 2

Count: **6** Missing: **0** ☒ **Corroded**

☒ **Evidence Of Surcharge** Depth: **4** (ft.) ☐ Active Surcharge Present

CORRODED STEPS AND EVIDENCE OF ASUR

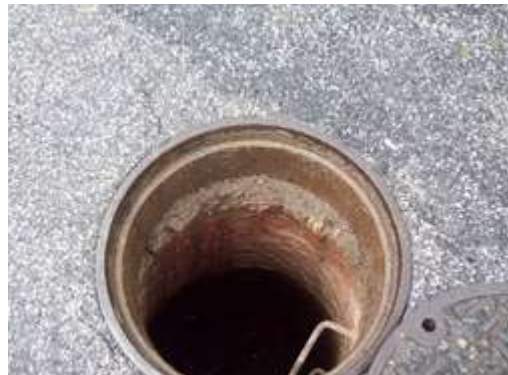
Defect 1

Offset: **3** (in.)

OFFSET FRAME

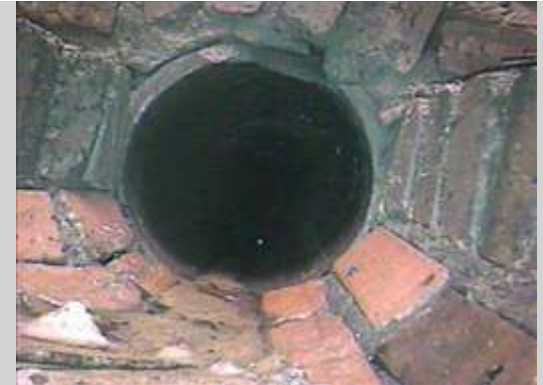
12 O'Clock Outflow

8 in. Circular Gravity Sewer
Pipe Out @ 12 O'Clock

Infiltration: **None** Pipe Seal Cond: **Sound**

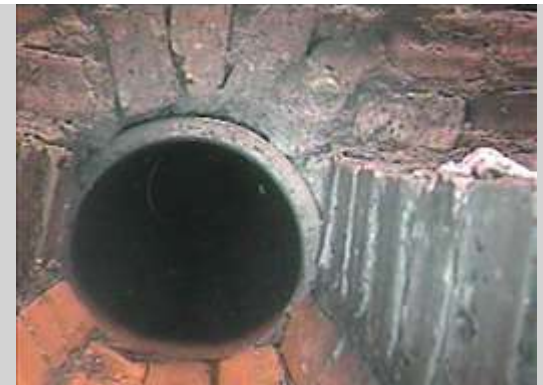
6 O'Clock Inflow

8 in. Circular Gravity Sewer
Pipe In @ 6 O'Clock

Infiltration: **None** Pipe Seal Cond: **Sound**

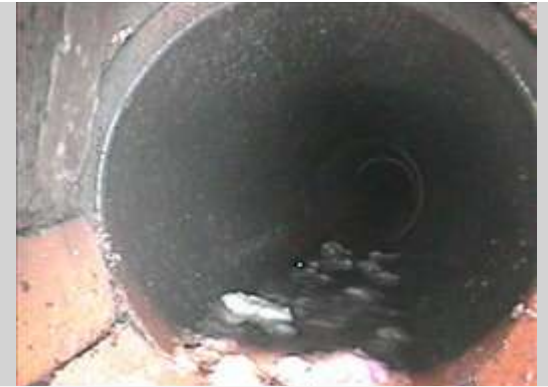
9 O'Clock Inflow

8 in. Circular Gravity Sewer

Pipe In @ 9 O'Clock

Infiltration: **None** Pipe Seal Cond: **Sound**
